Curtis Home Inspections

Property Inspection Report

13 Elm Street, Louisville, KY 40223
Inspection prepared for: Happy Homebuyer
Date of Inspection: 3/7/2023 Time: 9:00 AM
Age of Home: 1987 Size: 1134
Order ID: 4449

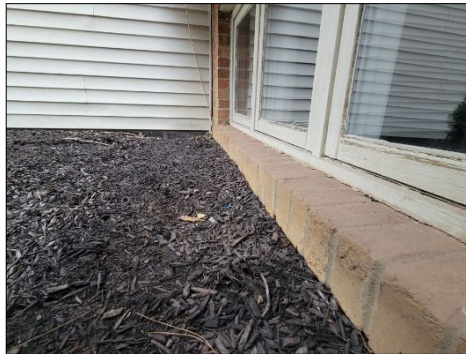
Page 8 Item: 1	Grading / Lot	Areas of flat or negative grading and/or low spots at certain areas around the home's perimeter were noted. This condition allows for drainage at the home's foundation that could adversely affect the foundation over time. The ground should slope away from the home a minimum of 1/4-inch per foot for a distance of at least ten feet from the foundation. Recommend add and slope dirt or rock around the home's perimeter or correct grading with other methods if necessary. NOTE: if drain tiles were installed, these areas may not accumulate water as much compared to if no drain tiles were installed. Verify with seller or other persons informed of the matter.
----------------	---------------	---

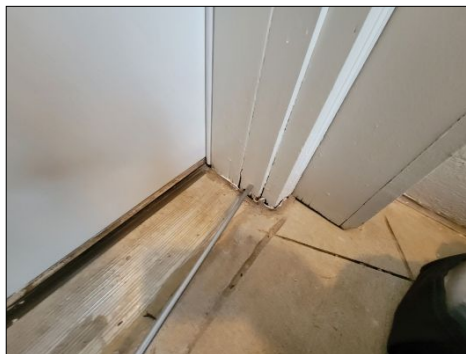
Front at bottom of steps

Page 11 Item: 1	Exterior Door Trim	• Trim around one or more doors had moderate damage and some wood rot. Recommend repair or replacement.
-----------------	--------------------	---

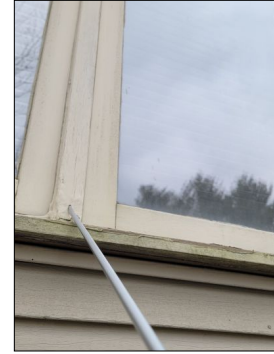
Page 12 Item: 1	EXTERIOR WINDOWS	<ul style="list-style-type: none"> • Moderate damage was noted at one or more window trims. Recommend repair and monitor. • Peeling paint was noted at one or more window trims. Recommend maintenance to prevent further sun damage.
-----------------	------------------	---

Some wood rot, front

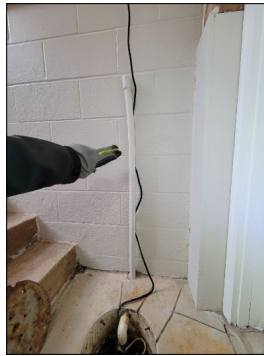
Page 19 Item: 1	Sump Pump	<ul style="list-style-type: none"> • The sump pump discharge pipe appeared to have no backwater or check valve installed. Recommend installation of a check valve by a qualified plumbing contractor to prevent discharged water from entering back into the sump, thus overworking the pump.
-----------------	-----------	--

No check valve observed

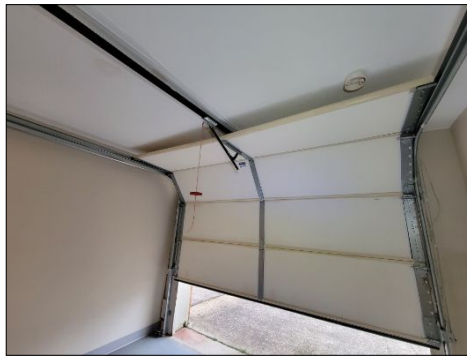
Page 20 Item: 1	Operation and Auto Reverse	<ul style="list-style-type: none"> • The overhead garage door opened and closed adequately, but made a popping sound when raised. This condition may indicate the need for adjustment. Recommend servicing by garage door specialist.
-----------------	----------------------------	--

Popping sound when opening

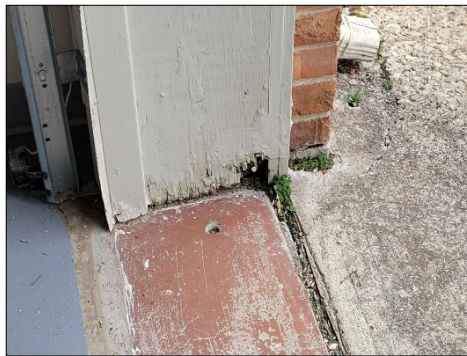
Page 21 Item: 3	Exterior Trim	<ul style="list-style-type: none"> • Areas of trim on the exterior of the overhead garage doors had moderate damage. Recommend repair in these areas.
-----------------	---------------	--

Some wood rot

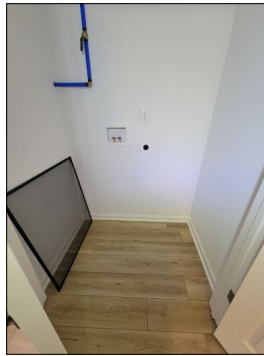
Page 23 Item: 2	Laundry Area	<ul style="list-style-type: none"> • The Inspector did not observe an opening for the dryer exhaust line. Recommend installation of an exhaust line that properly terminates to the exterior of the home by a qualified contractor.
-----------------	--------------	--

No dryer exhaust opening

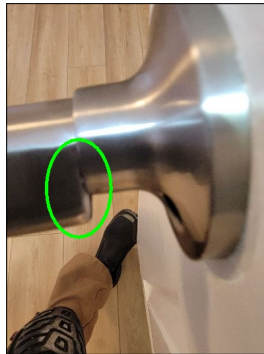
Page 31 Item: 1	Interior Doors	<ul style="list-style-type: none"> • Several door knobs/locks were installed incorrectly and/or were defective, but operated. The configuration left the handle piece offset, which has a sharp edge that may cause injury. Recommend modification or replacement to prevent potential injury.
-----------------	----------------	---

One of several with sharp piece/offset

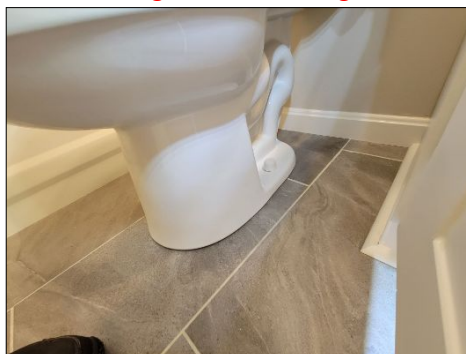
Page 32 Item: 2	Toilet Condition	<ul style="list-style-type: none"> • In this bathroom, the toilet was loose at the floor and should be re-attached by a qualified plumbing contractor to prevent leakage and damage.
-----------------	------------------	---

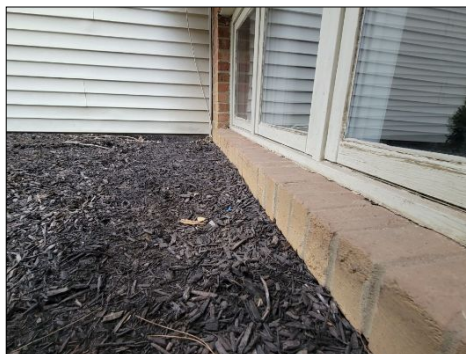
Observations: Areas of flat or negative grading and/or low spots at certain areas around the home's perimeter were noted. This condition allows for drainage at the home's foundation that could adversely affect the foundation over time. The ground should slope away from the home a minimum of ¼-inch per foot for a distance of at least ten feet from the foundation. Recommend add and slope dirt or rock around the home's perimeter or correct grading with other methods if necessary. NOTE: if drain tiles were installed, these areas may not accumulate water as much compared to if no drain tiles were installed. Verify with seller or other persons informed of the matter.

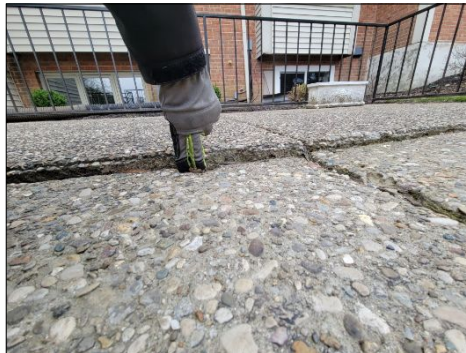
- The walkways showed signs of weathering commensurate for its age. Recommend monitor and routine maintenance.
- Minor settling/heaving at one more areas of the walkways was noted. These areas did not appear to cause a trip hazard. Recommend repair and monitor.

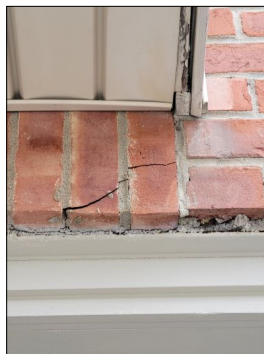
Above garage overhead door

- The brick wall veneer showed signs of common weathering. Recommend routine maintenance and monitoring.
- Minor cracking was noted through brick and mortar at one or more locations along the exterior wall. Recommend fill any cracks wider than 1/4" with appropriate material and correct exterior grading to slope away from the home and monitor, if needed.

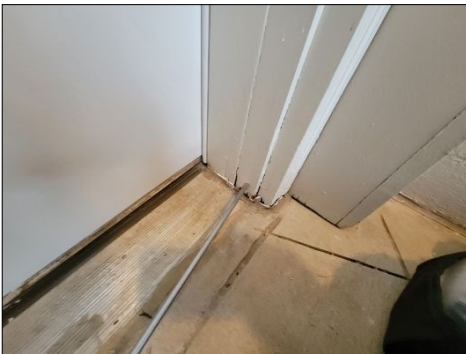
Front at bottom of steps

- Trim around one or more doors had moderate damage and some wood rot. Recommend repair or replacement.

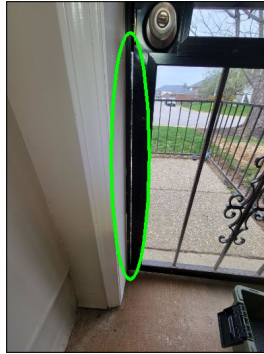
- One or more exterior storm doors had damaged or missing weatherstripping. Recommend correction to prevent heat/cooling loss, drafts from the exterior or potential moisture intrusion.

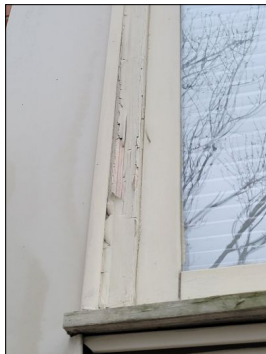
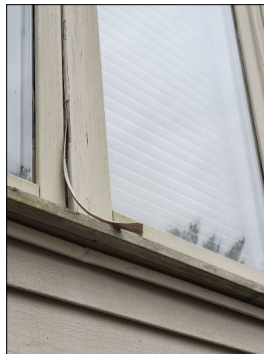
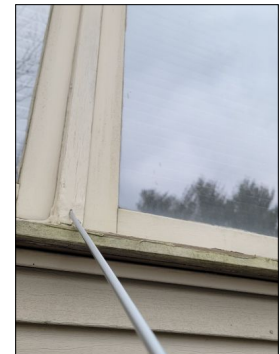
- Window exteriors exhibited moderate general deterioration. Recommend routine maintenance and monitoring.
- Moderate damage was noted at one or more window trims. Recommend repair and monitor.
- Peeling paint was noted at one or more window trims. Recommend maintenance to prevent further sun damage.

Some wood rot, front

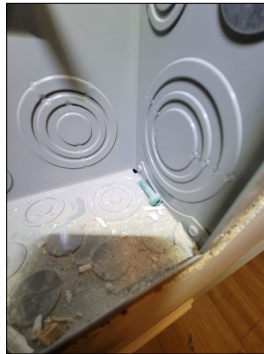
- No bonding screw or strap was observed in the electrical panel as required. Recommend further evaluation and modification by an electrical contractor.

Bonding screw not attached, required for main panels (this is not a remote distribution panel)

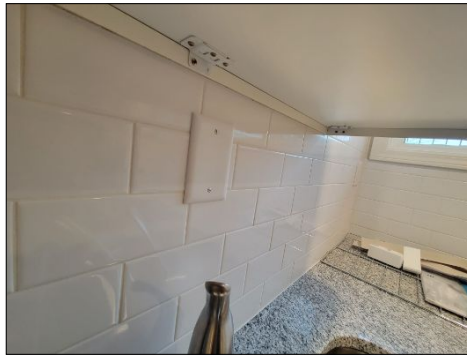
Kitchen

- One or more blank cover plates were noted. These plates typically indicate a previous installation of switches, receptacles and/or phone, cable, satellite or internet wires. Recommend ask sellers about their history and remove wires and patch if no longer needed.

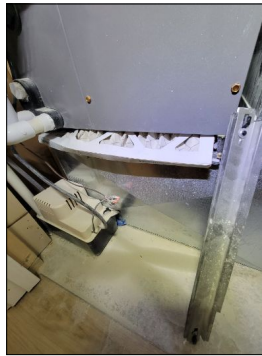
- The air filter for this heat pump was located in/behind a sliding panel in the return air duct at the interior unit.
- The air filter for this heat pump was the wrong size or type. This condition can allow particulates to pass beyond the filter and into indoor air or may result in the filter being sucked into the blower, causing damage to the blower and creating a potential fire hazard. Recommend correction.

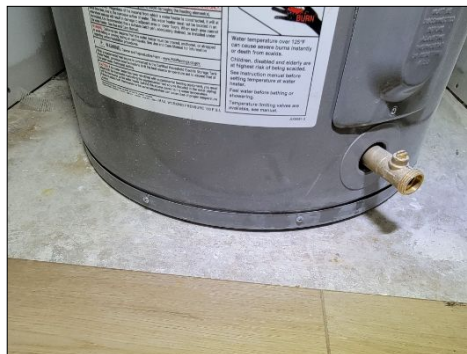
- Although this water heater was installed in a location in which leakage of the tank or plumbing connections would cause damage, no drip pan was installed. A proper drip pan with an overflow pipe should be installed by a qualified plumbing contractor to prevent possible water damage.

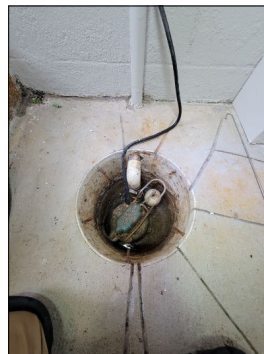
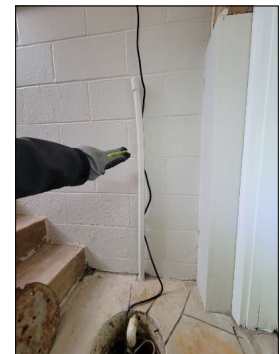
- At the time of the inspection, the Inspector observed no deficiencies in the operation of the sump pump. Sump pumps require periodic maintenance to ensure that they work when they're needed. The Inspector recommends having it serviced immediately and annually in the future.
- The sump pump discharge pipe appeared to have no backwater or check valve installed. Recommend installation of a check valve by a qualified plumbing contractor to prevent discharged water from entering back into the sump, thus overworking the pump.

No check valve observed

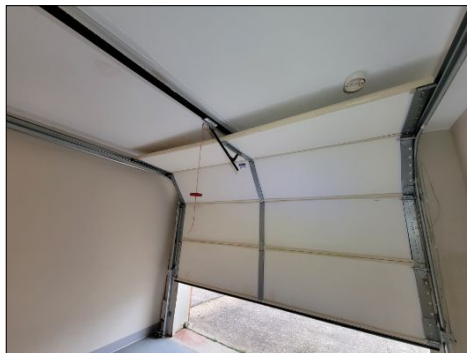
- One or more overhead garage doors had an automatic opener installed.
- One or more automatic garage door openers had an operable photo sensor activated automatic reverse device installed, but did not respond to testing of any pressure activated automatic reverse feature. Garage doors are required to have at least one automatic-reverse device. Recommend monitor and/or add pressure sensor if desired to increase safety.
- The overhead garage door opened and closed adequately, but made a popping sound when raised. This condition may indicate the need for adjustment. Recommend servicing by garage door specialist.

Popping sound when opening

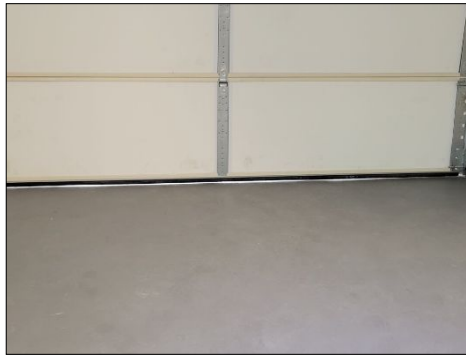
- The weatherstripping under the garage overhead door appeared to have shrunk, leaving one or more gaps under the door. This condition is common. Recommend add weatherstripping if desired.

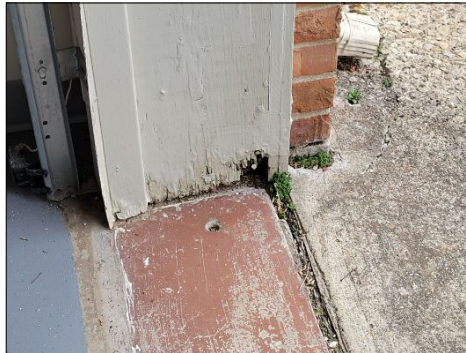
- Areas of trim on the exterior of the overhead garage doors had moderate damage. Recommend repair in these areas.

Some wood rot

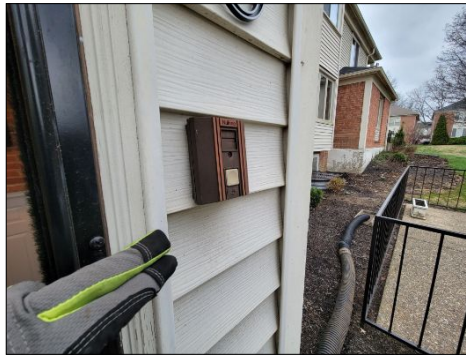
- The home interior showed minor general wear and deterioration commensurate with its age.
- One or more components of the home intercom system appeared to be inoperable. These systems are typically low-voltage systems that require routine maintenance to work properly. Recommend repair or replacement if continued is desired.
- A fire suppression system was installed. This system is designed to extinguish a fire in the interior by releasing a liquid or foam under pressure from spray nozzles mounted on the ceiling throughout the area. Inspection of fire suppression systems lies beyond the scope of the General Home Inspection. The system was not inspected. Recommend ask sellers about its operation, maintenance history and requirements and/or seek inspection from a contractor.

Intercom appears inoperable

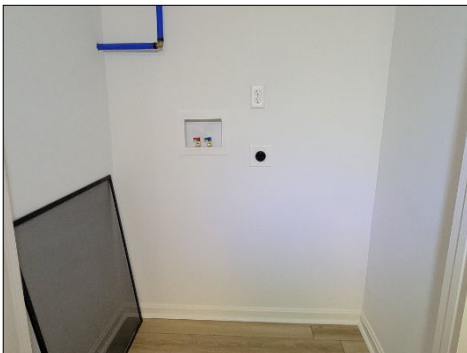
• The Inspector did not observe an opening for the dryer exhaust line. Recommend installation of an exhaust line that properly terminates to the exterior of the home by a qualified contractor.

Four prong dryer cord required

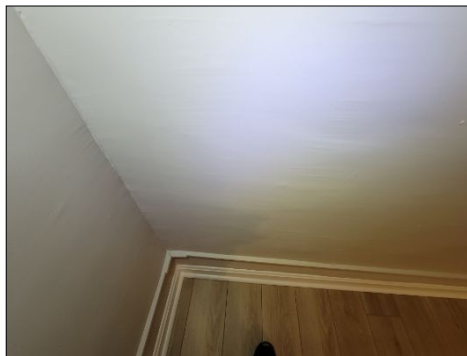
- "Nail pops" were noted in the walls at one or more locations. Nail pops often occur happen when the nail loses its grip in the wood stud and pulls out a tad, often from normal settling, then the sheetrock pulls away from the stud. Afterwards, the sheetrock moves back and the nail doesn't. To repair a nail pop, drive the nail in with a nail set, apply a screw one inch above or below, and finish the area. If the home has stopped settling, this should correct the problem.

One of several locations

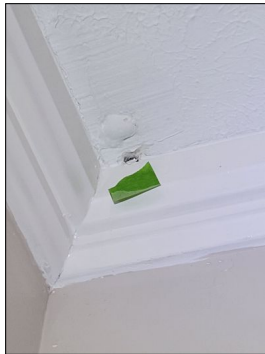
- The Inspector observed cosmetic imperfections and/or common settling cracks in the ceilings. Recommend correct any cosmetic appearances and monitor. NOTE: any other ceiling deficiencies or notations will be listed elsewhere in this section,
- One or more areas of the ceiling were noted to be imperfect, lacked sanding, had mismatched paint or had staining from items like sticky kids toys (often kids throw slime type items on ceilings that leave stains). These areas were dry at the time of the inspection. Recommend correct cosmetic appearance and monitor.
- One or more areas of the ceiling were damaged. Recommend repair by a qualified contractor.

Primary bedroom, dry

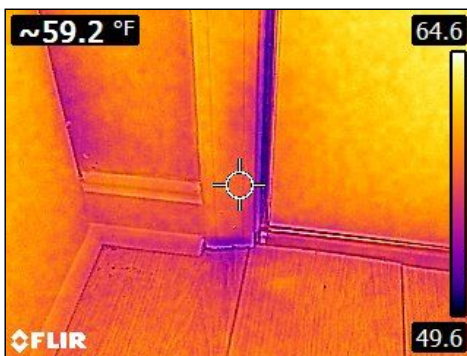
Indicates some cool air entering entry door (storm door at top of stairs needs new weatherstripping/adjustment)

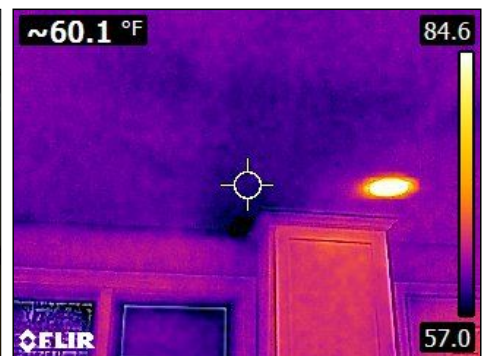
Indicates missing insulation in kitchen ceiling at front wall

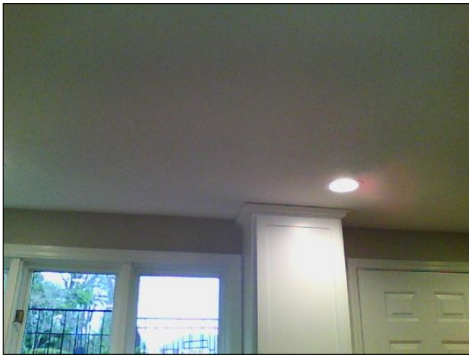
Indicates missing insulation in kitchen ceiling at front wall

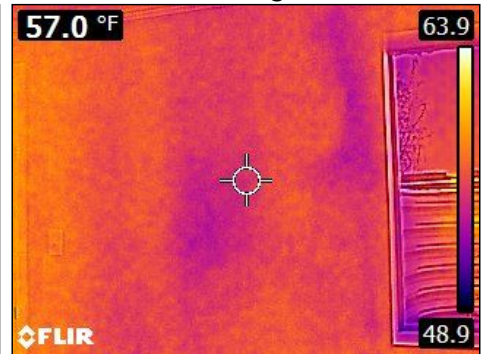
Indicates missing insulation in primary bedroom on front wall near window

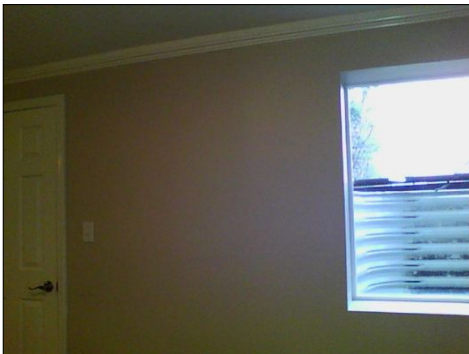
Indicates missing insulation in primary bedroom on front wall near window

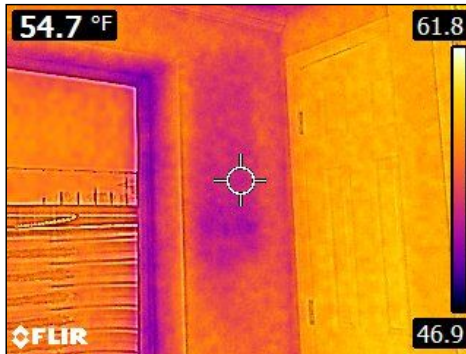
Indicates missing insulation in primary bedroom on front wall near window

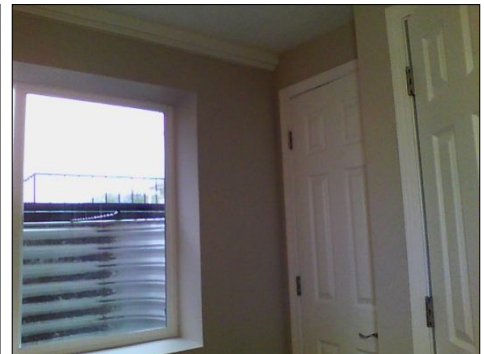
Indicates missing insulation in primary bedroom on front wall near window

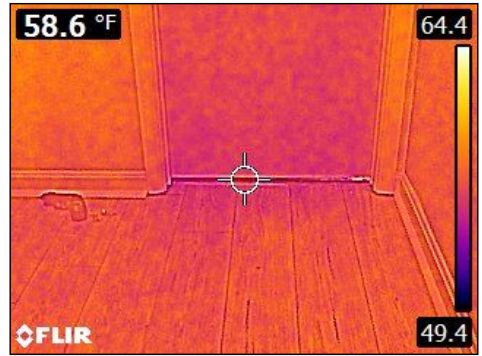
Indicates some cold air coming through garage entry door (the weather sealed/fire-rated door in beyond this door)

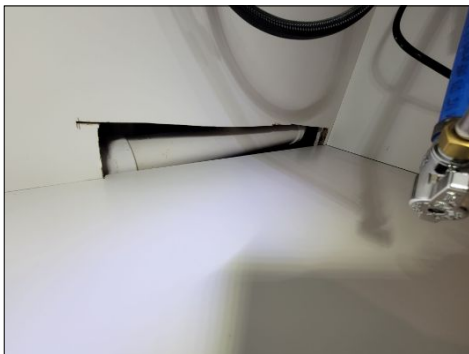
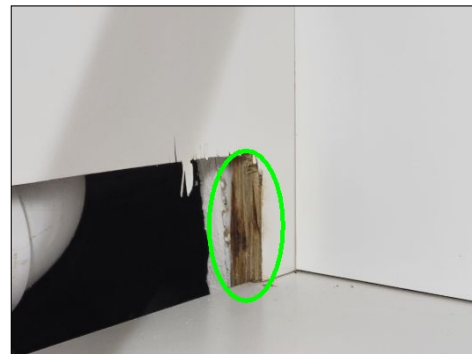
- Minor damage and/or holes from previous installations was noted under one or more kitchen sinks. Recommend correct cosmetic appearances and monitor.
- The cabinet wall, floor and/or pipes under the sink was noted to have signs of previous moisture intrusion. This area was dry at the time of the inspection, indicating that the leakage may have been corrected or is intermittent. Recommend correct cosmetic appearance and monitor.

Currently dry

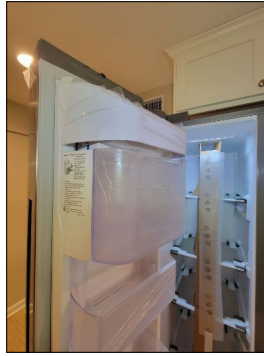
- The ice maker at the refrigerator was inoperable or off. Recommend verification of operation, repair or replacement.

Brand new, ice maker not on

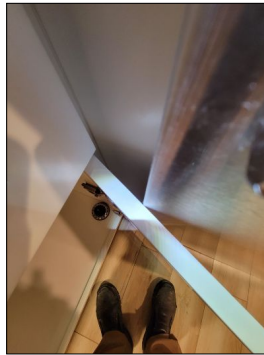
- One or more kitchen cabinet drawers or doors was not able to be opened fully due to making contact with the adjacent drawers, doors, drawer hardware, dishwasher, range or fridge. Recommend adjust, replace hardware and/or note.

Door hits dishwasher

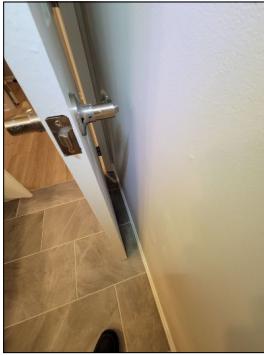
- One or more interior doors in the home had a missing or damaged stop. This condition has or may result in wall damage. Recommend addition of a new doorstop in these areas and repair of any cosmetic damage. NOTE: any pictures shown are representative and thus, other similar conditions may exist.
- One or more interior doors in the home was binding on the jamb when opened or closed. Recommend adjustment.
- One or more interior doors in the home did not stay open on its own or closed on its own. These doors may be out of square. Recommend adjustment.
- Several door knobs/locks were installed incorrectly and/or were defective, but operated. The configuration left the handle piece offset, which has a sharp edge that may cause injury. Recommend modification or replacement to prevent potential injury.

Missing door stop, bathroom

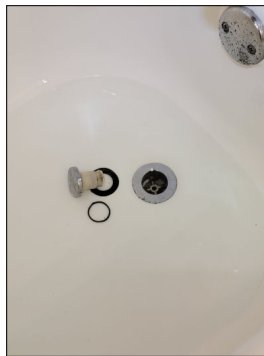
- The stopper at the tub in one or more bathrooms was in need of adjustment to operate properly. Recommend adjustment or replacement.

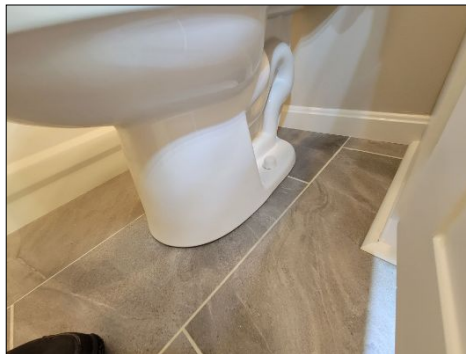
- In this bathroom, the toilet was loose at the floor and should be re-attached by a qualified plumbing contractor to prevent leakage and damage.
