Curtis Home Inspections

Property Inspection Report

13 Elm Street, Louisville, KY 40223
Inspection prepared for: Happy Homebuyer
Date of Inspection: 3/7/2023 Time: 9:00 AM
Age of Home: 1987 Size: 1134
Order ID: 4449

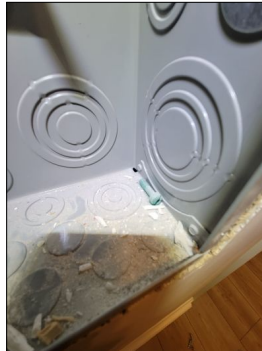
Page 14 Item: 3	Wiring Defects	<ul style="list-style-type: none"> • No bonding screw or strap was observed in the electrical panel as required. Recommend further evaluation and modification by an electrical contractor.
-----------------	----------------	--

Bonding screw not attached, required for main panels (this is not a remote distribution panel)

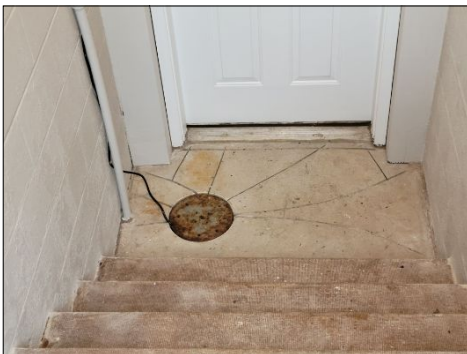
Concrete lines cut for accepting water into sump pump

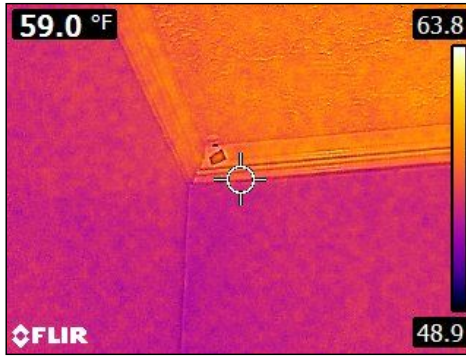
Indicates dry repair, primary bedroom ceiling at corner

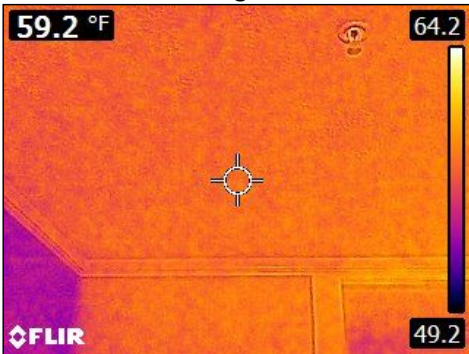
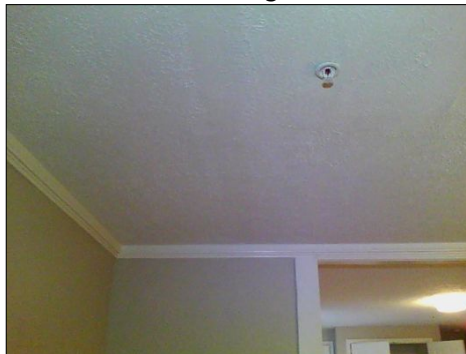
Indicated previous repair dry, ceiling in primary bedroom

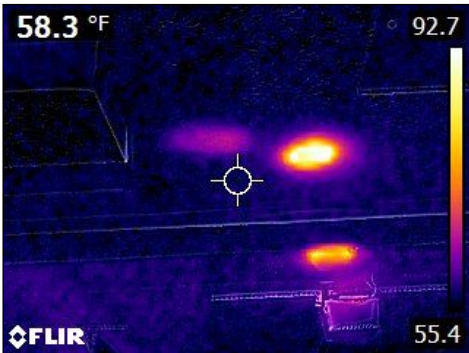
Indicates a bit of heat in garage ceiling (likely the junction box for the recessed light nearby), okay of contained in box

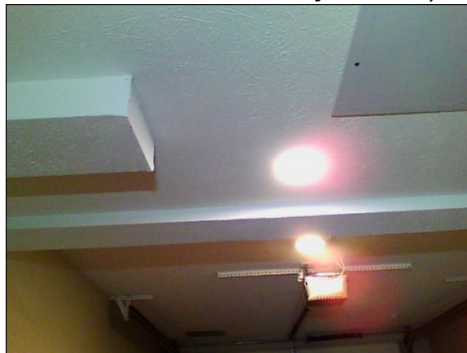
Indicates a bit of heat in garage ceiling (likely the junction box for the recessed light nearby), okay of contained in box

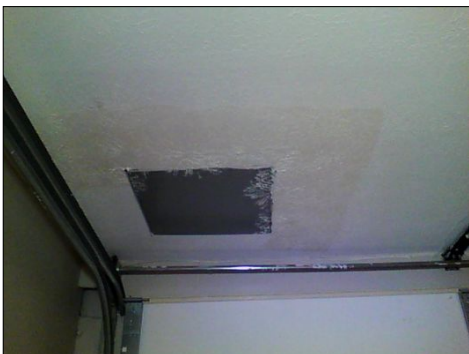
Indicates repair at panel in garage ceiling dry

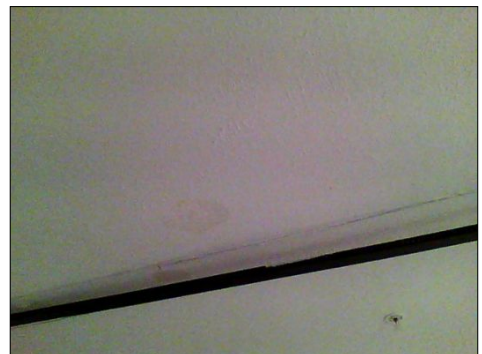
Indicates repair at garage ceiling dry

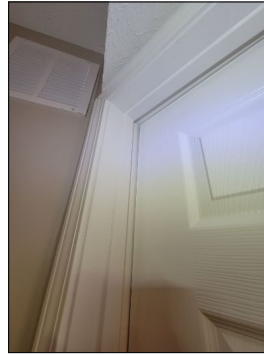
Jambs, primary bedroom
