Curtis Home Inspections

Property Inspection Report

13 Elm Street, Louisville, KY 40223
Inspection prepared for: Happy Homebuyer
Date of Inspection: 3/7/2023 Time: 9:00 AM
Age of Home: 1987 Size: 1134
Order ID: 4449

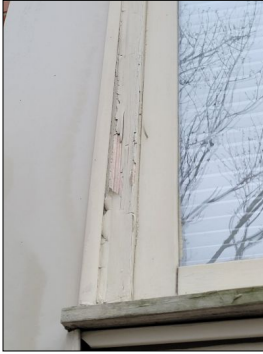
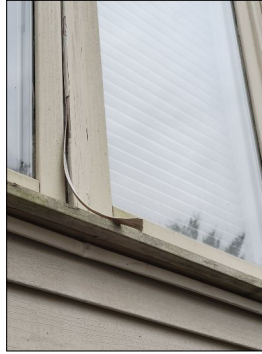
Page 12 Item: 1	EXTERIOR WINDOWS	<ul style="list-style-type: none"> • Moderate damage was noted at one or more window trims. Recommend repair and monitor. • Peeling paint was noted at one or more window trims. Recommend maintenance to prevent further sun damage.
-----------------	------------------	---

Some wood rot, front

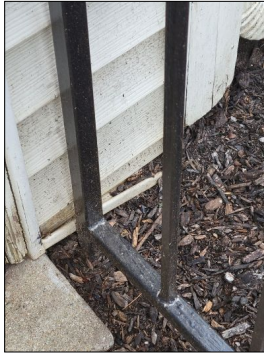
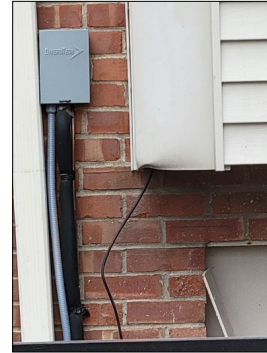
Front

- The vinyl siding covering exterior walls had areas of minor damage that appeared to be cosmetic only. Recommend note and repair if desired.
- One or more areas of the siding were in need of pressure washing due to growth from being in a shaded area or from other weather events. Recommend cleaning and routine maintenance to protect the siding.

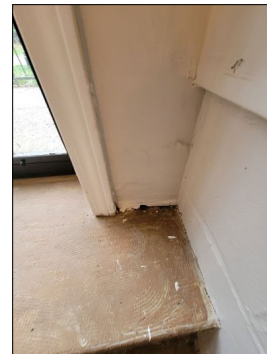
Front

- Trim around one or more doors had moderate damage and some wood rot. Recommend repair or replacement.

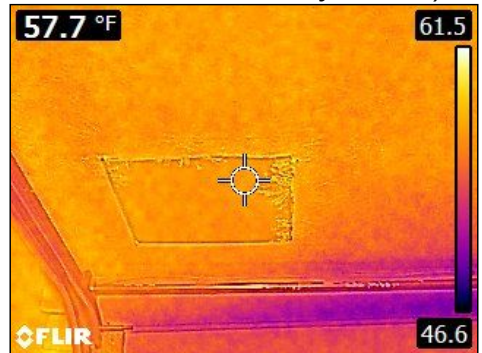
Indicates repair at panel in garage ceiling dry

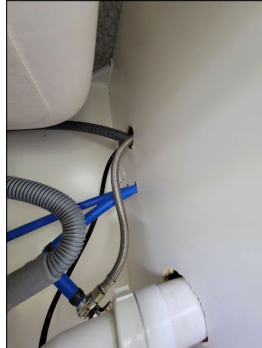
- The dishwasher did not appear to have a high loop configured in the drain line. The high loop is designed to prevent wastewater from contaminating the dishwasher. To correct, the drain hose should be hung up with a bracket at a high point on the back of the cabinet wall, similar to a roller coaster hill. Sometimes this configuration is built into the unit in newer models. Recommend verify and correction if needed.

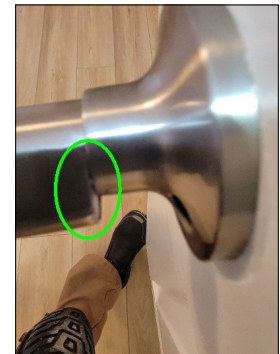
One of several with sharp piece/offset
